NATIONAL BUREAU OF STANDARDS REPORT

AN INVESTIGATION ON THE FIRE SPREAD POTENTIAL OF PLASTIC PIPE INSTALLATIONS

10 342

I. A. Benjamin and W. J. Parker

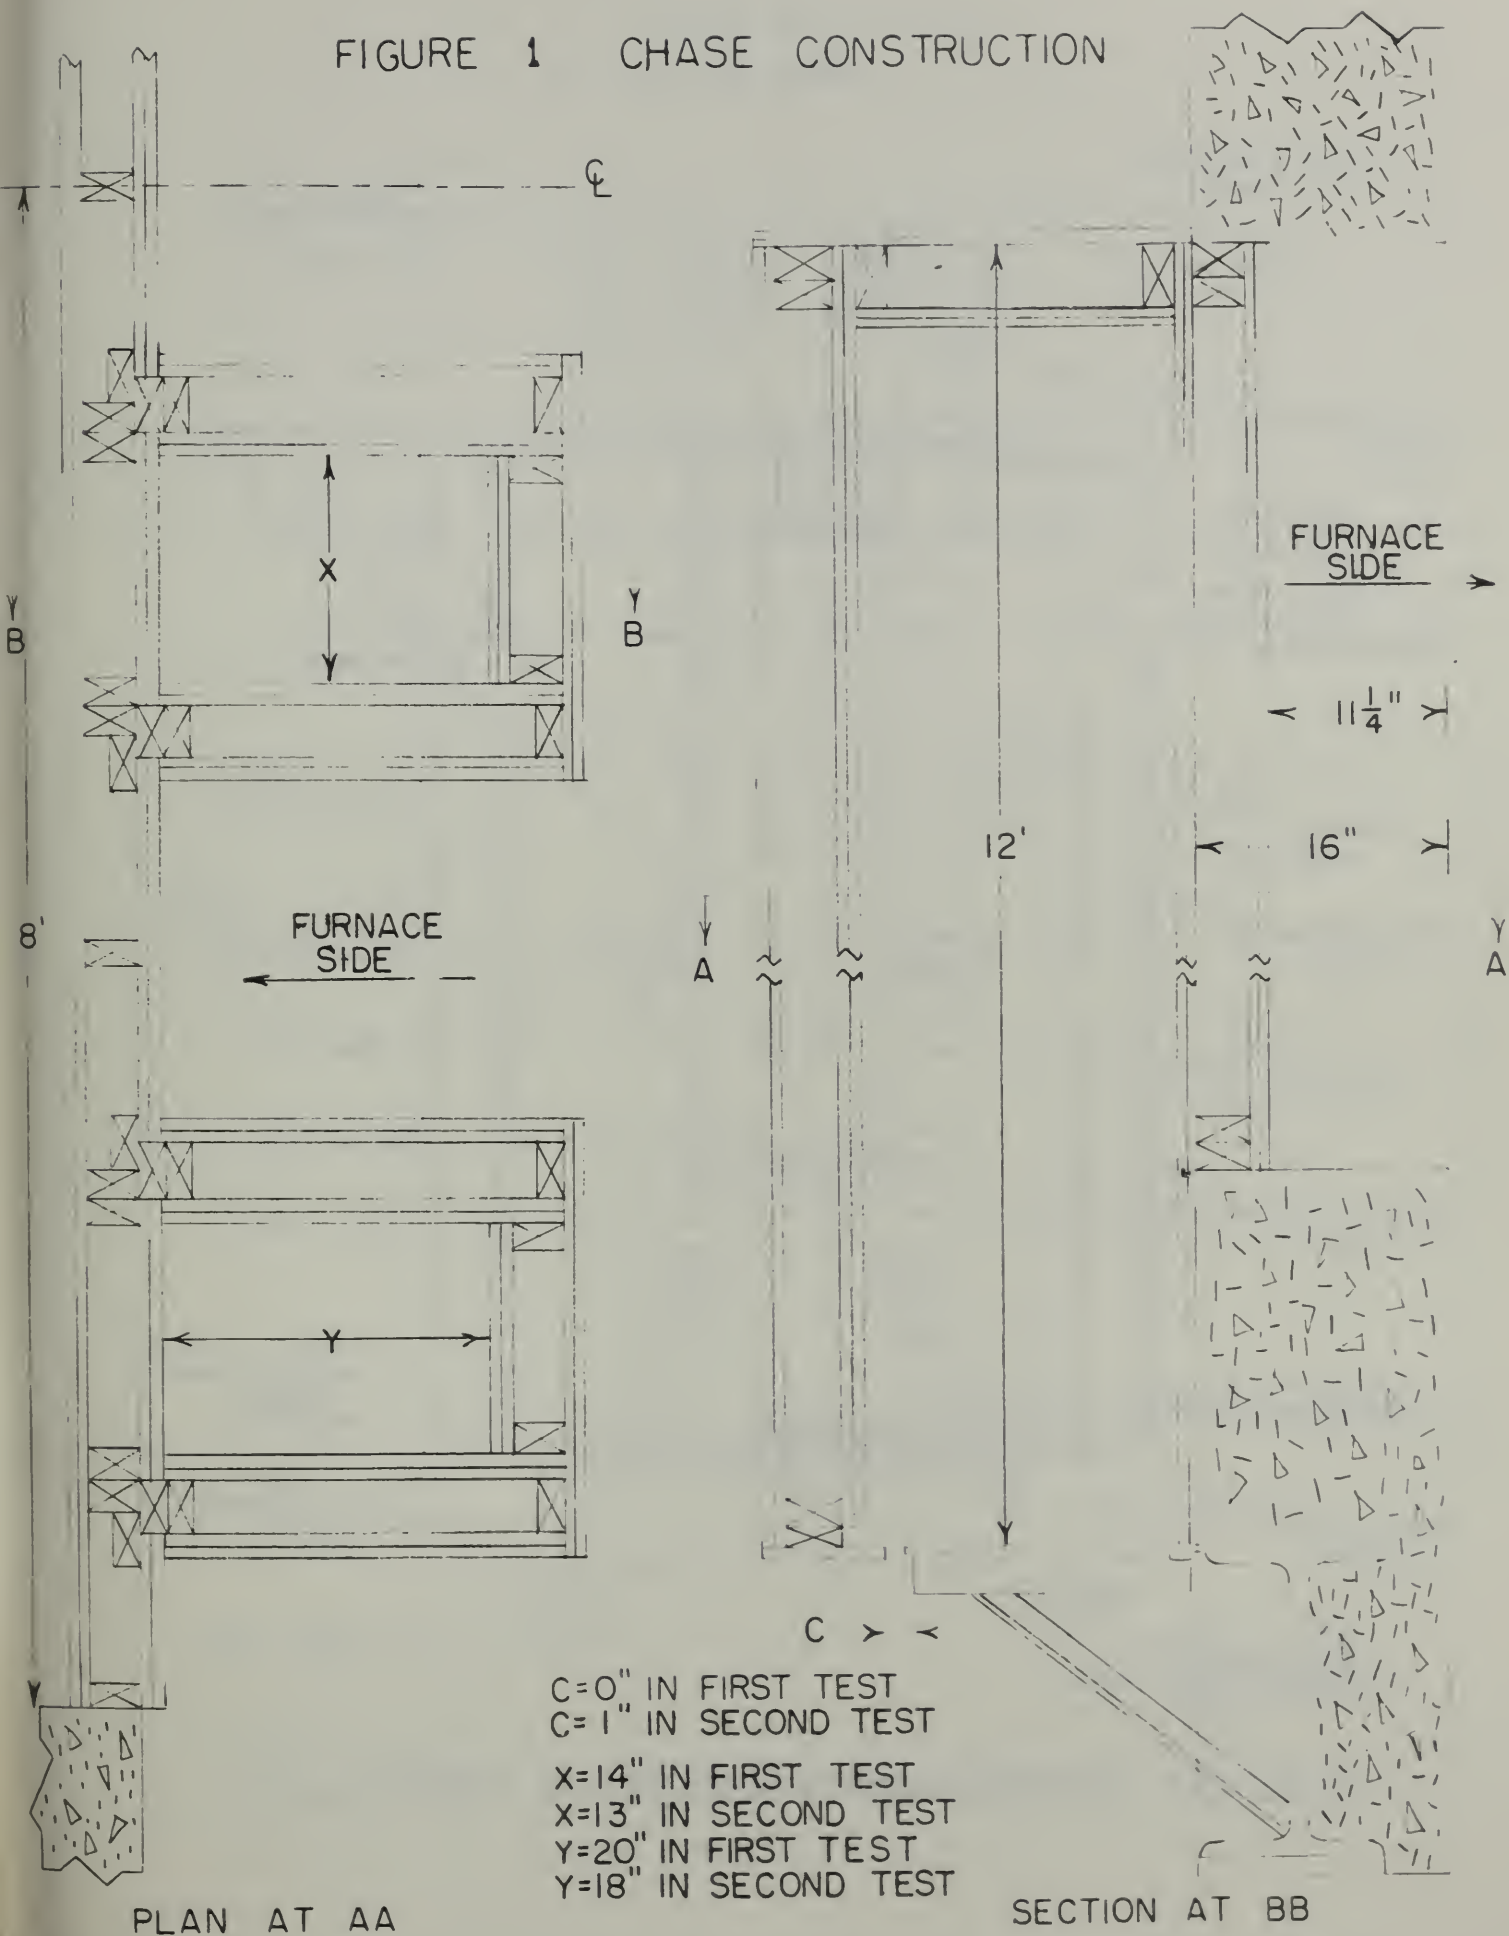
FIGURE 1 CHASE CONSTRUCTION

Four chases were built on each panel as shown in figure 1. Each chase had two layers of 5/8" type "X" gypsum board on each side of the 2 x 4 fir stud framing. This is a construction comparable to "Design No. 4 - 2 hour Combustible" fire resistance classification in the Underwriter's Laboratories Building Materials List. The chases were 12 feet high and were supported at the bottom by a steel shelf. The cross sections were 20 x 14 inches on the first panel, and 18 x 13 inches on the second panel. There was a strip 1 x 13 inches inadvertently left open at the bottom of the chases in the second test. Otherwise, the chases were closed, but the joints on the gypsum board were not taped. The gypsum board surface exposed to the furnace was unfinished in the first panel and was protected by a layer of sprayed fireproofing over metal lath on the second panel.

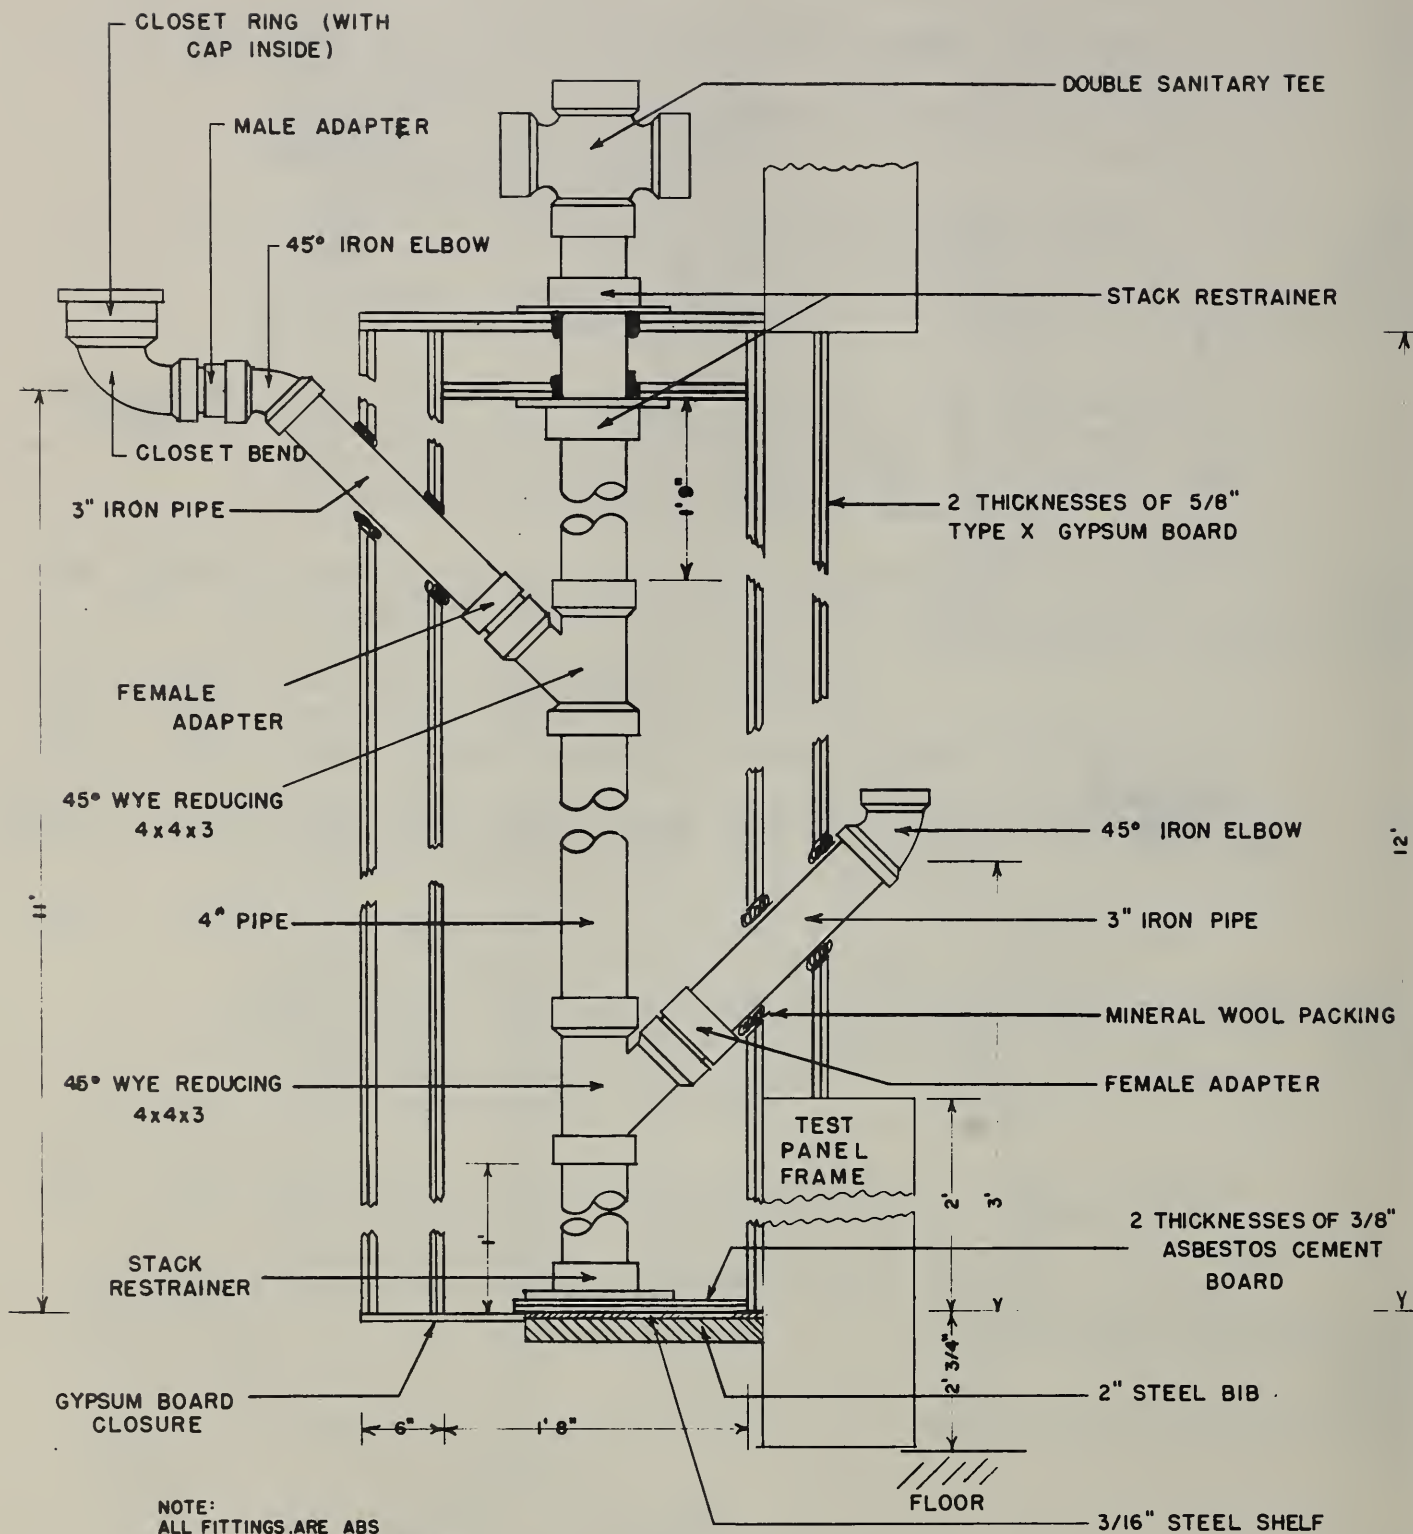
FIGURE 2A PIPING ARRANGEMENT IN CHASE 1

The pipe installation used in chase 1 is shown in figure 2A. The vertical pipe, four inches in diameter, was terminated at the top and bottom of the chase by ABS stack restrainers. The lower stack restrainer rested on two 3/8 inch thick sheets of asbestos cement board which sealed off the bottom of the pipe. For the first panel test the pipe opened into a double sanitary tee above the chase, which was used for smoke measurements. This tee was not used with the four chases on the second panel.

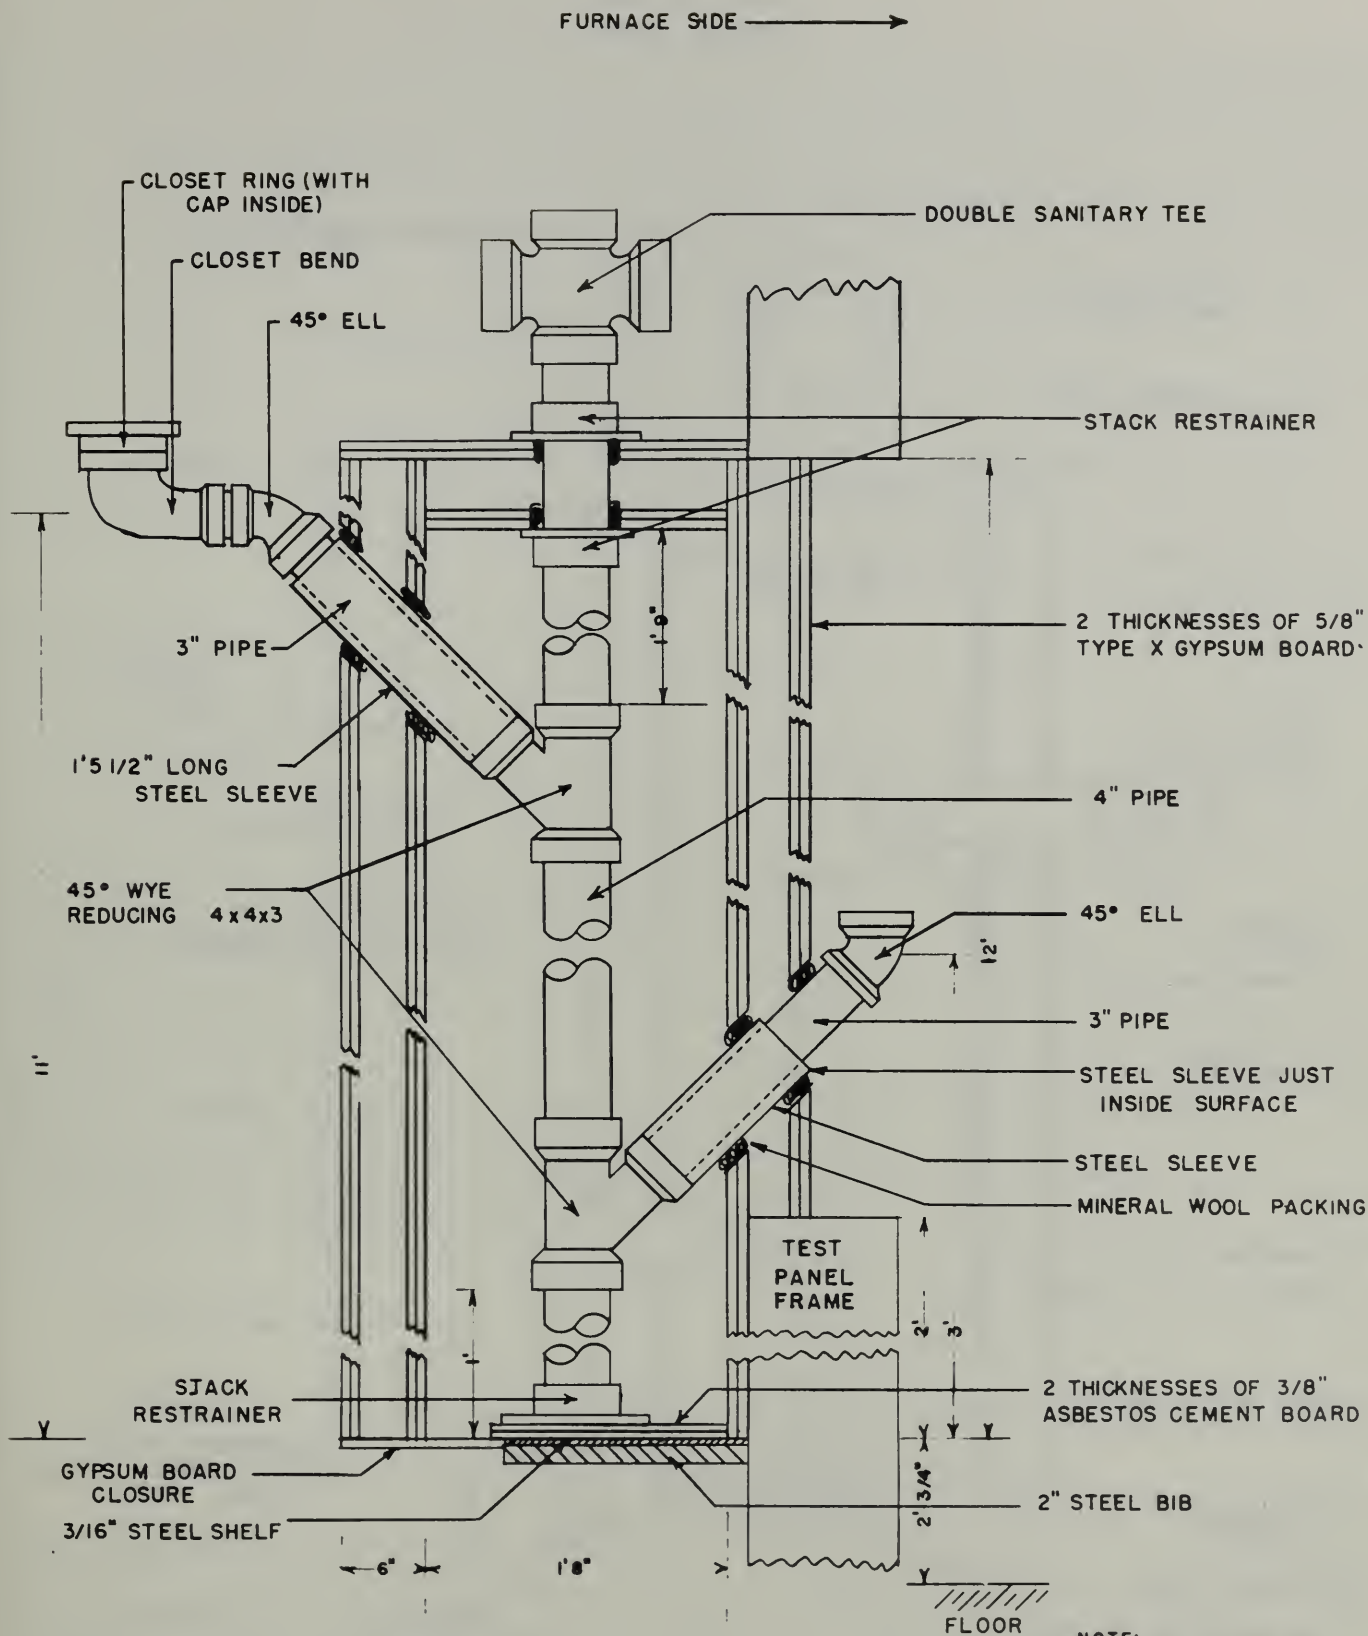
FIGURE 2B PIPING ARRANGEMENT IN CHASE 2

Chase 2 differed from Chase 1 in that the galvanized iron pipe laterals were replaced by ABS pipes sheathed in 5 inch O.D. steel sleeves 17 1/2 inches long, as shown in figure 2B. The iron elbows were replaced by ones of ABS and the adapters were not needed.

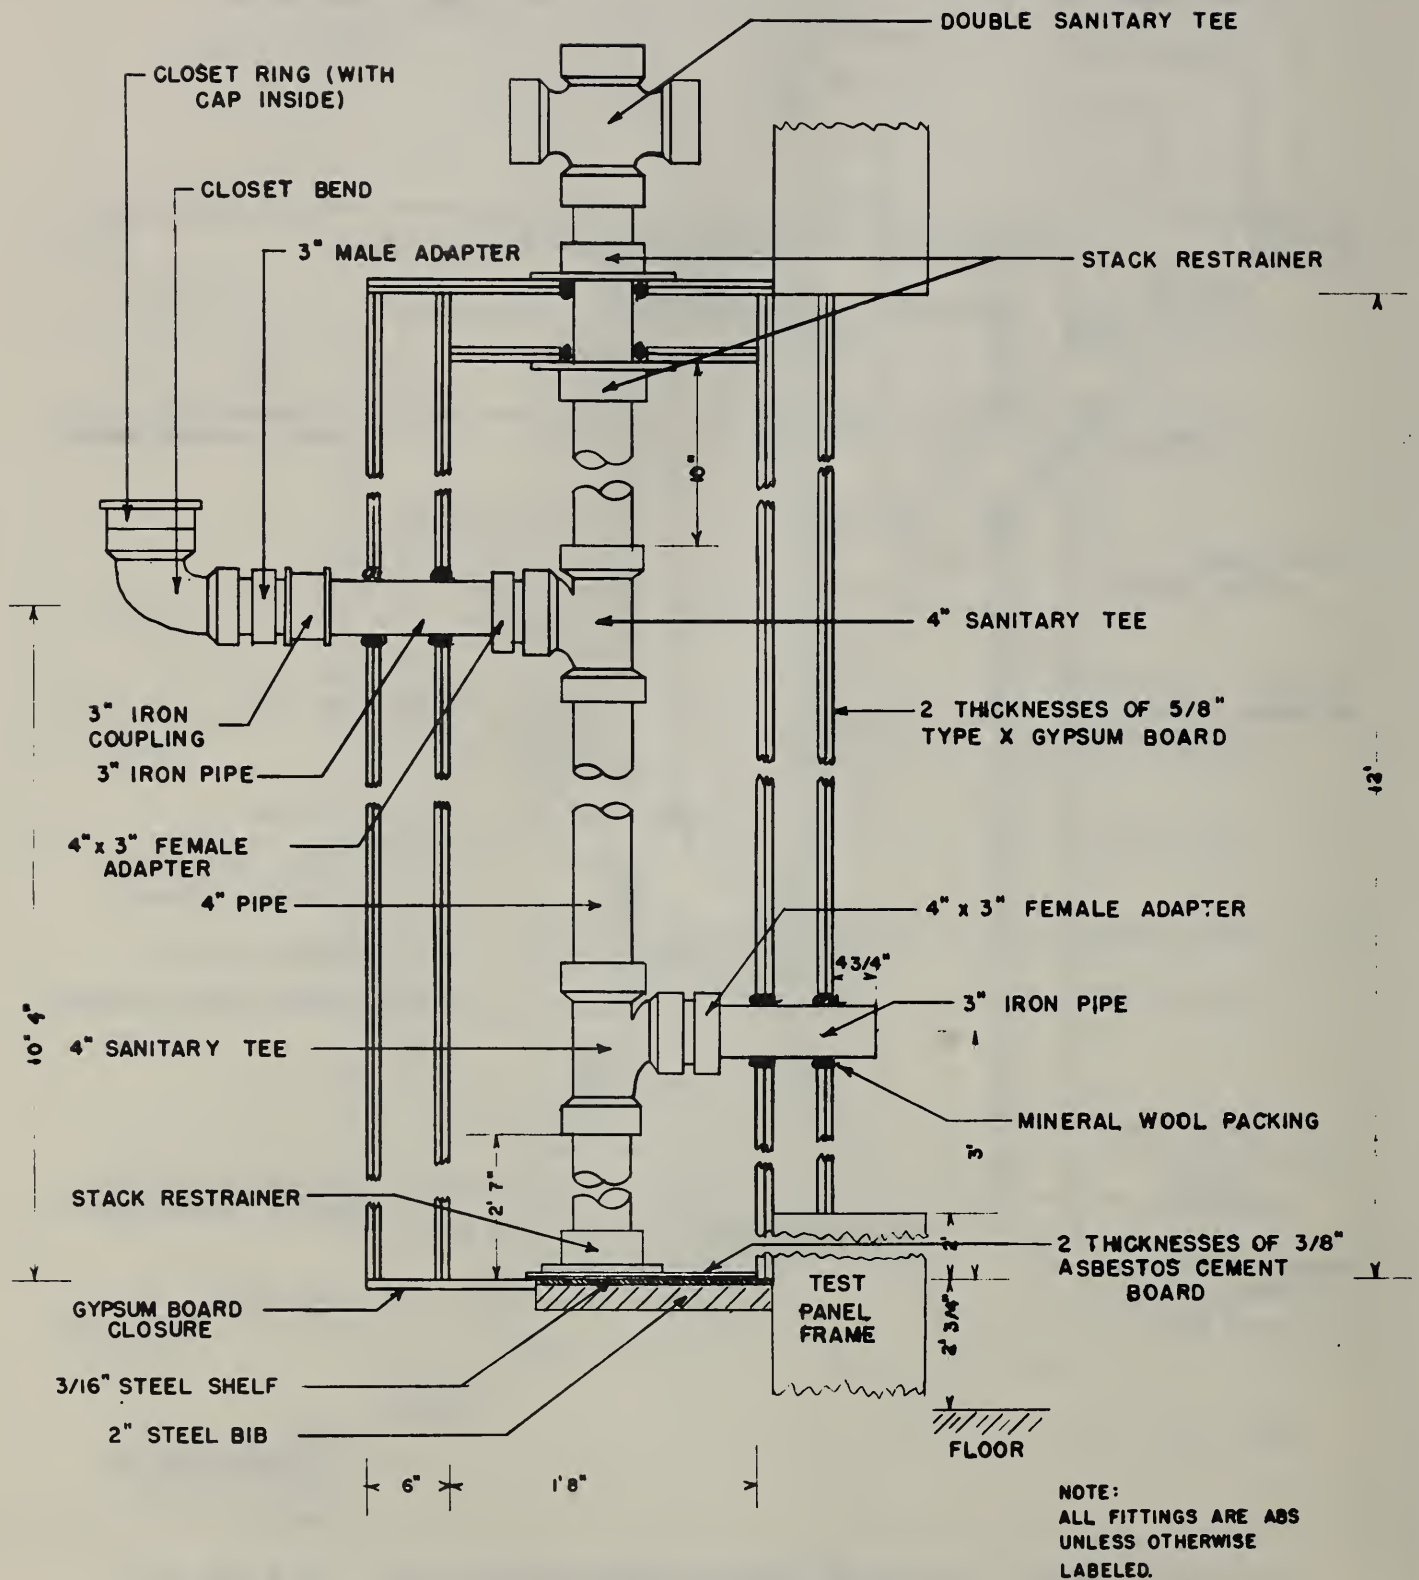
FIGURE 2C PIPING ARRANGEMENT IN CHASE 3

In Chase 3 single sanitary reducing tees replaced the 45° wyes and the 3 inch diameter galvanized iron pipes were connected to the tees by adapters. The iron pipes passed horizontally through the chase walls. This is shown in figure 2C. There was no fitting at the end of the pipe which projected into the furnace. The upper lateral iron pipe was terminated with an iron coupling connected to an identical set of fittings as that used in Chase 1.

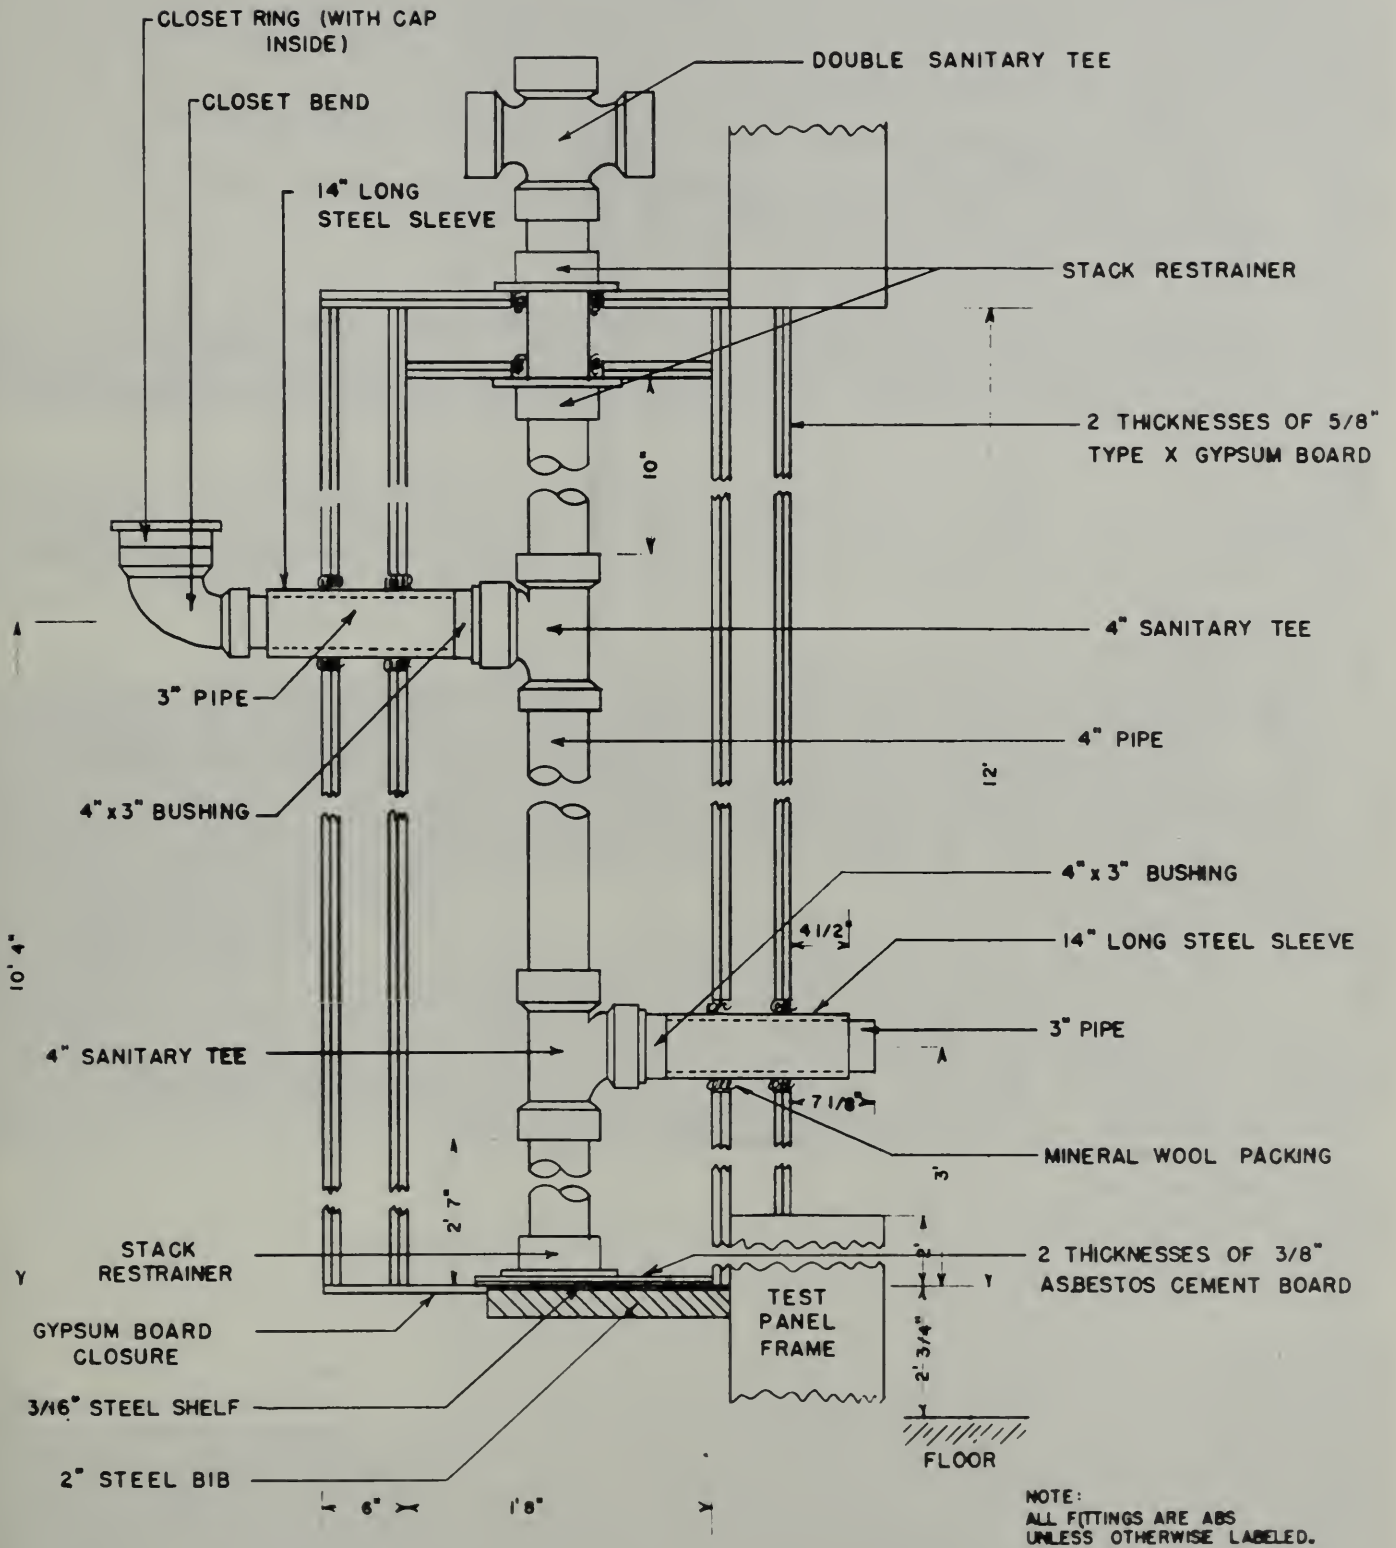
FIGURE 2D PIPING ARRANGEMENT IN CHASE 4

The installation in Chase 4 which is shown in figure 2D was the same as in Chase 3 except that ABS pipes with steel sleeves were used as in Chase 2. The adapters and the iron coupling were not needed.

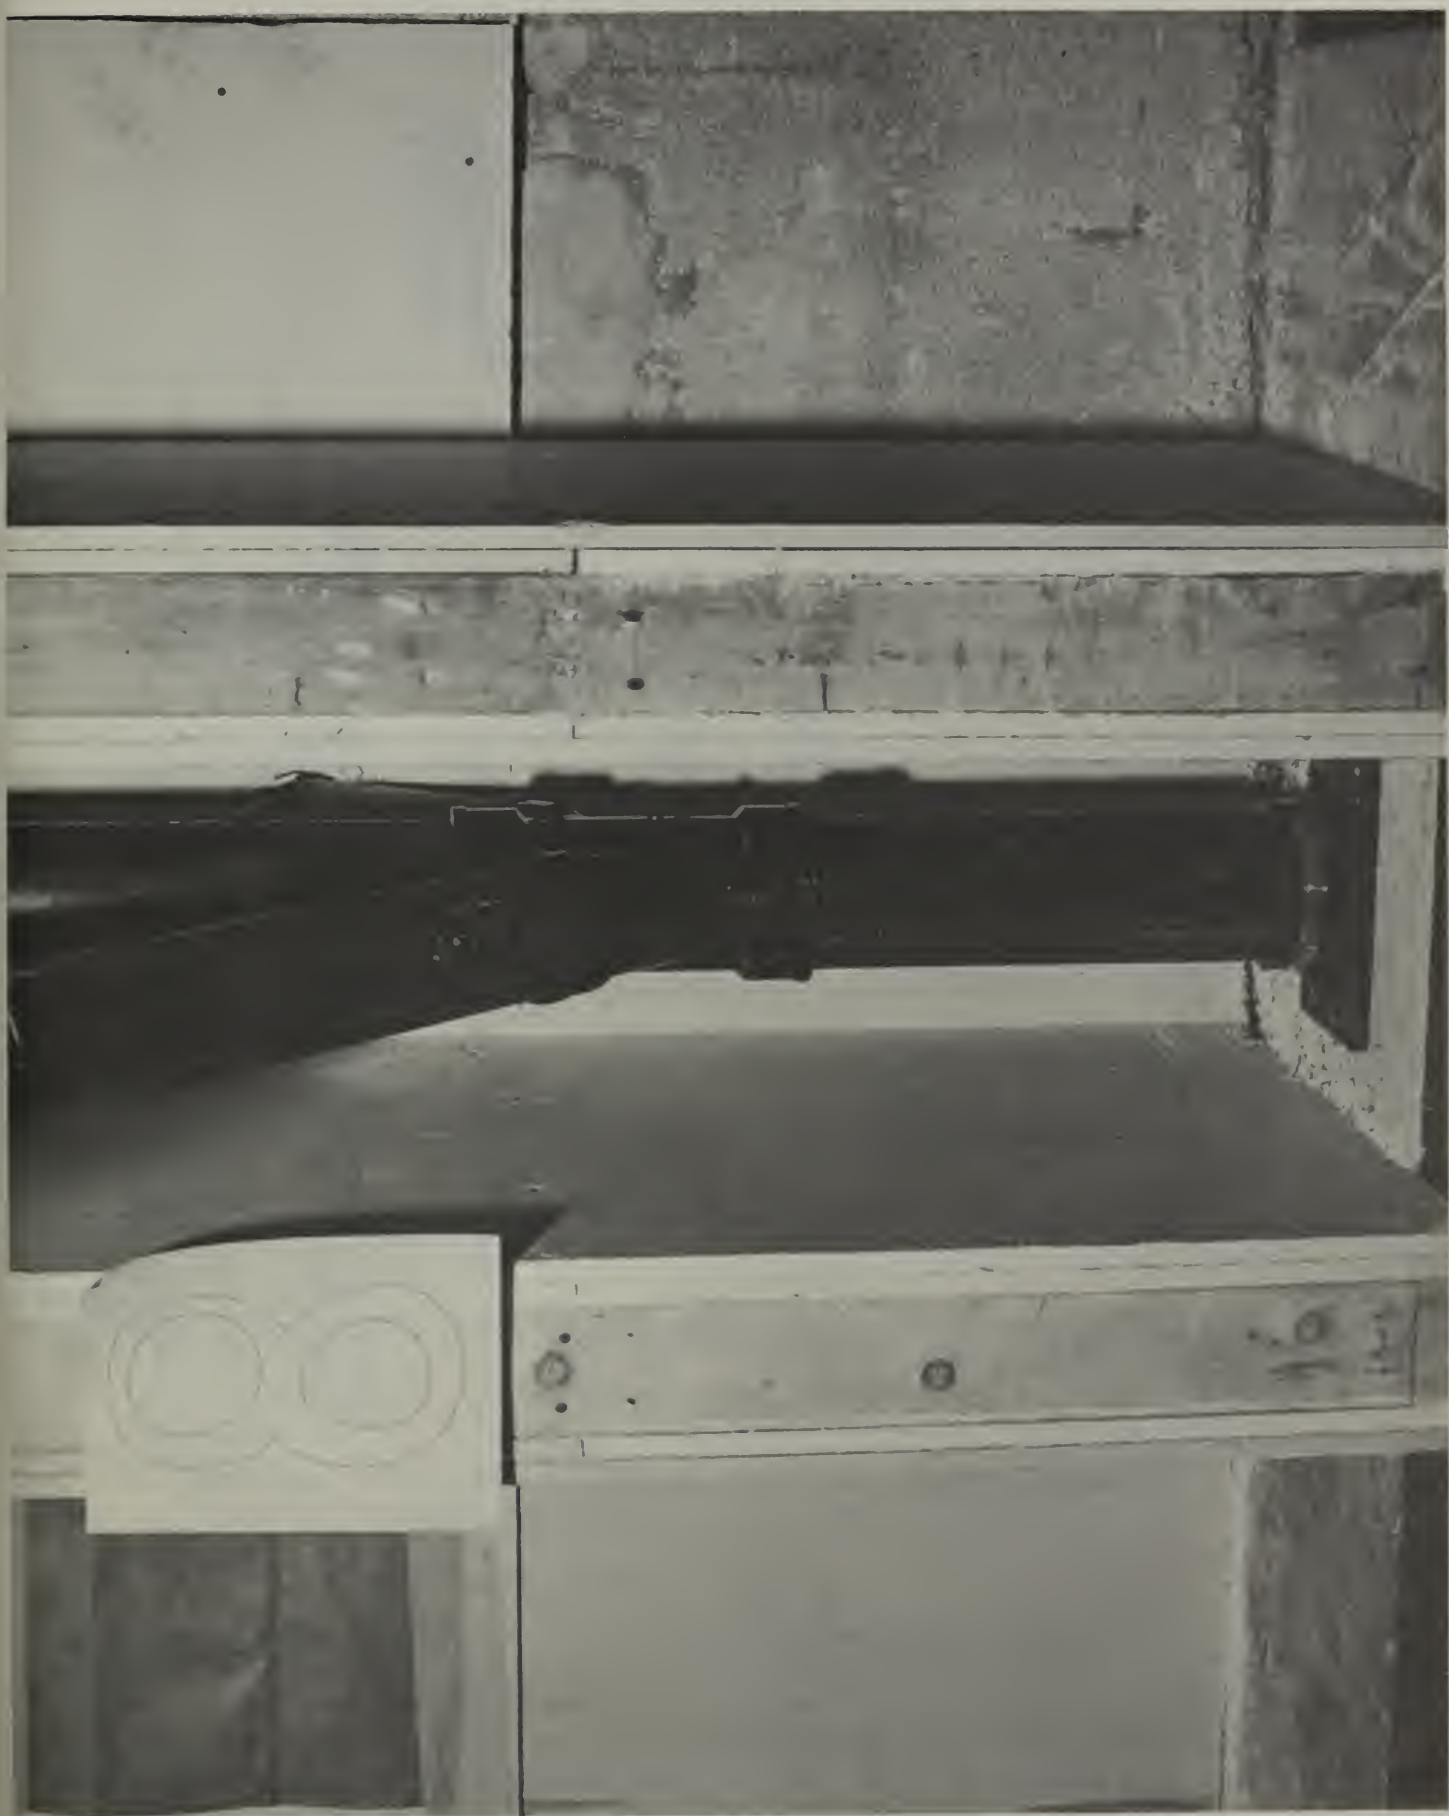
Chase 5 had one lower lateral with a single 45° wye and a steel sleeve. Chase 6 had one lower lateral and no steel sleeve. Chase 7 had two lower laterals with a double 45° wye and no steel sleeves. Chase 8 had two lower laterals with a double 45° wye and steel sleeves. A photograph of the lower lateral of Chase 8 is shown in figure 3.

Fig. 3. Lower Branch of Chase 8

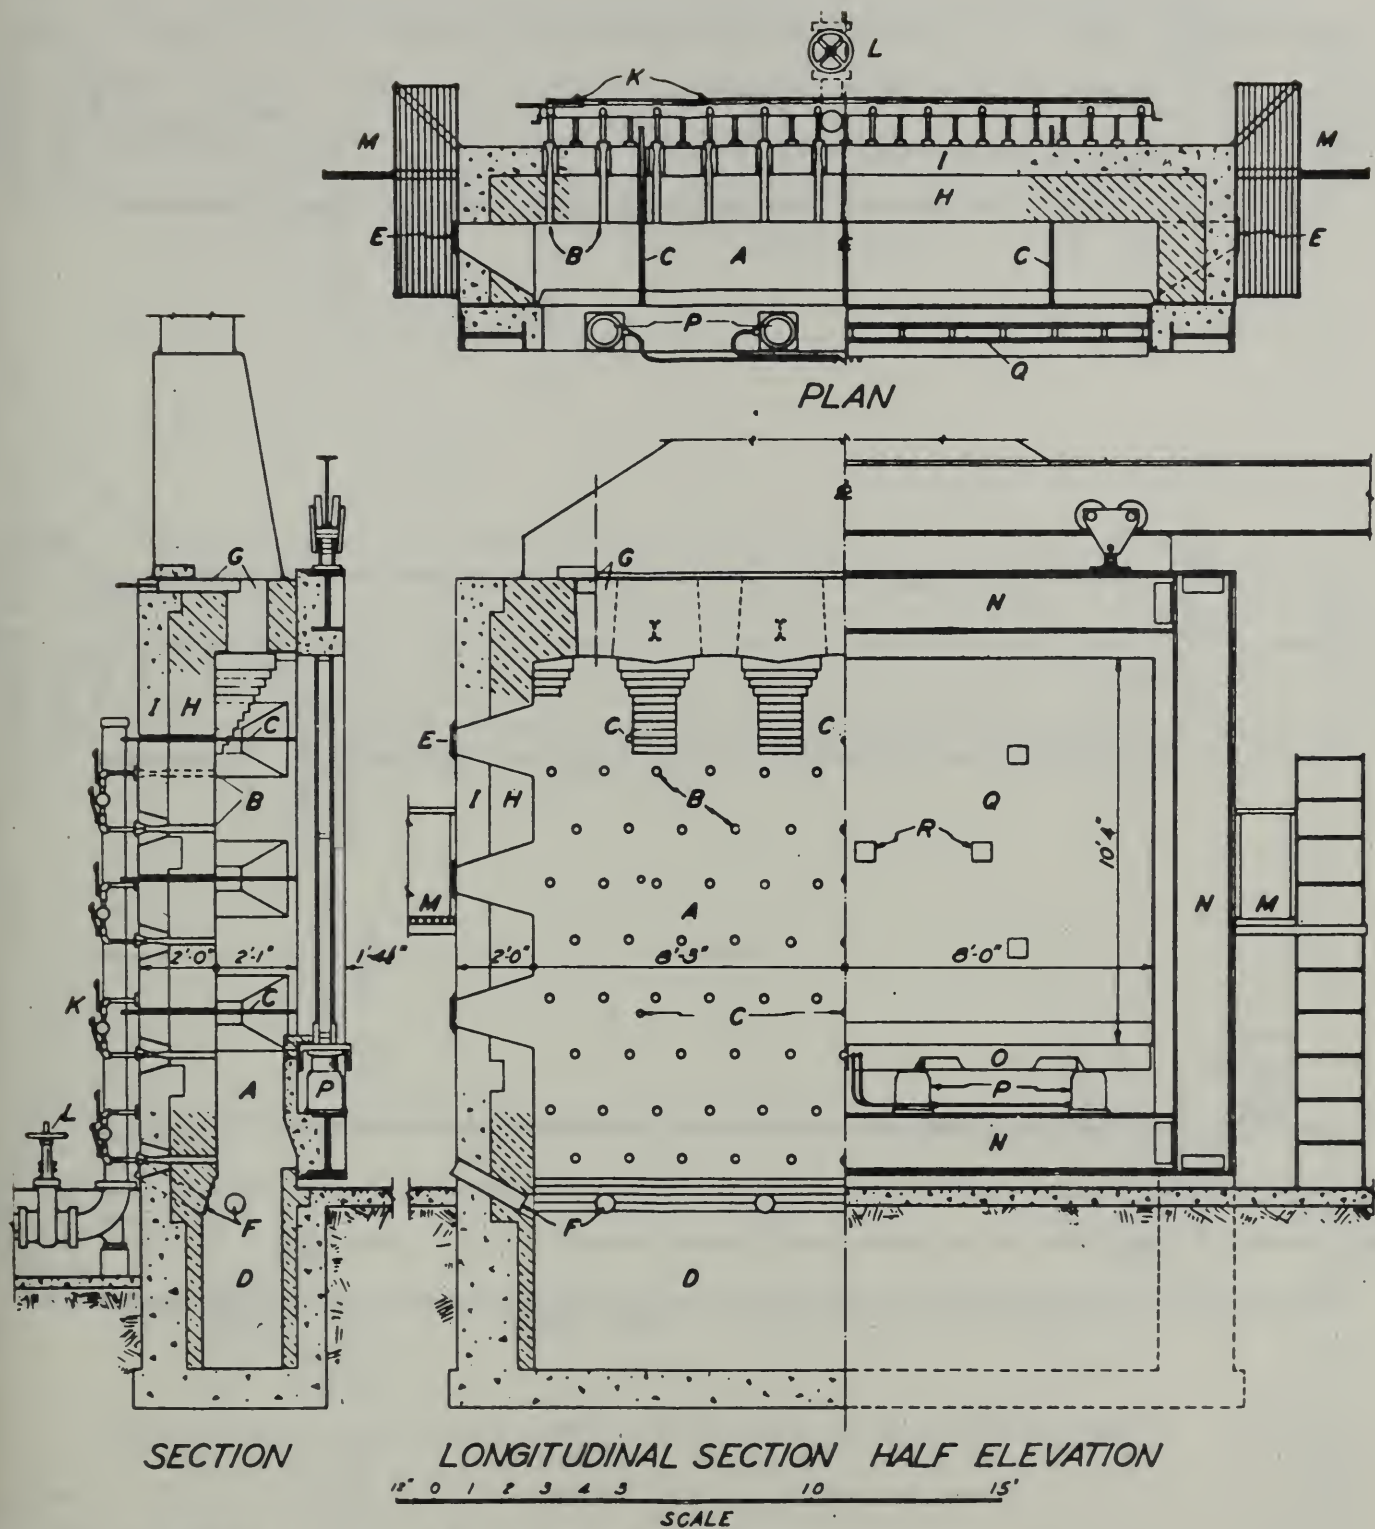
FIGURE 4 DETAILS OF WALL-TESTING FURNACE.

The panel with the four chases was moved in front of the wall furnace shown in figure 4.

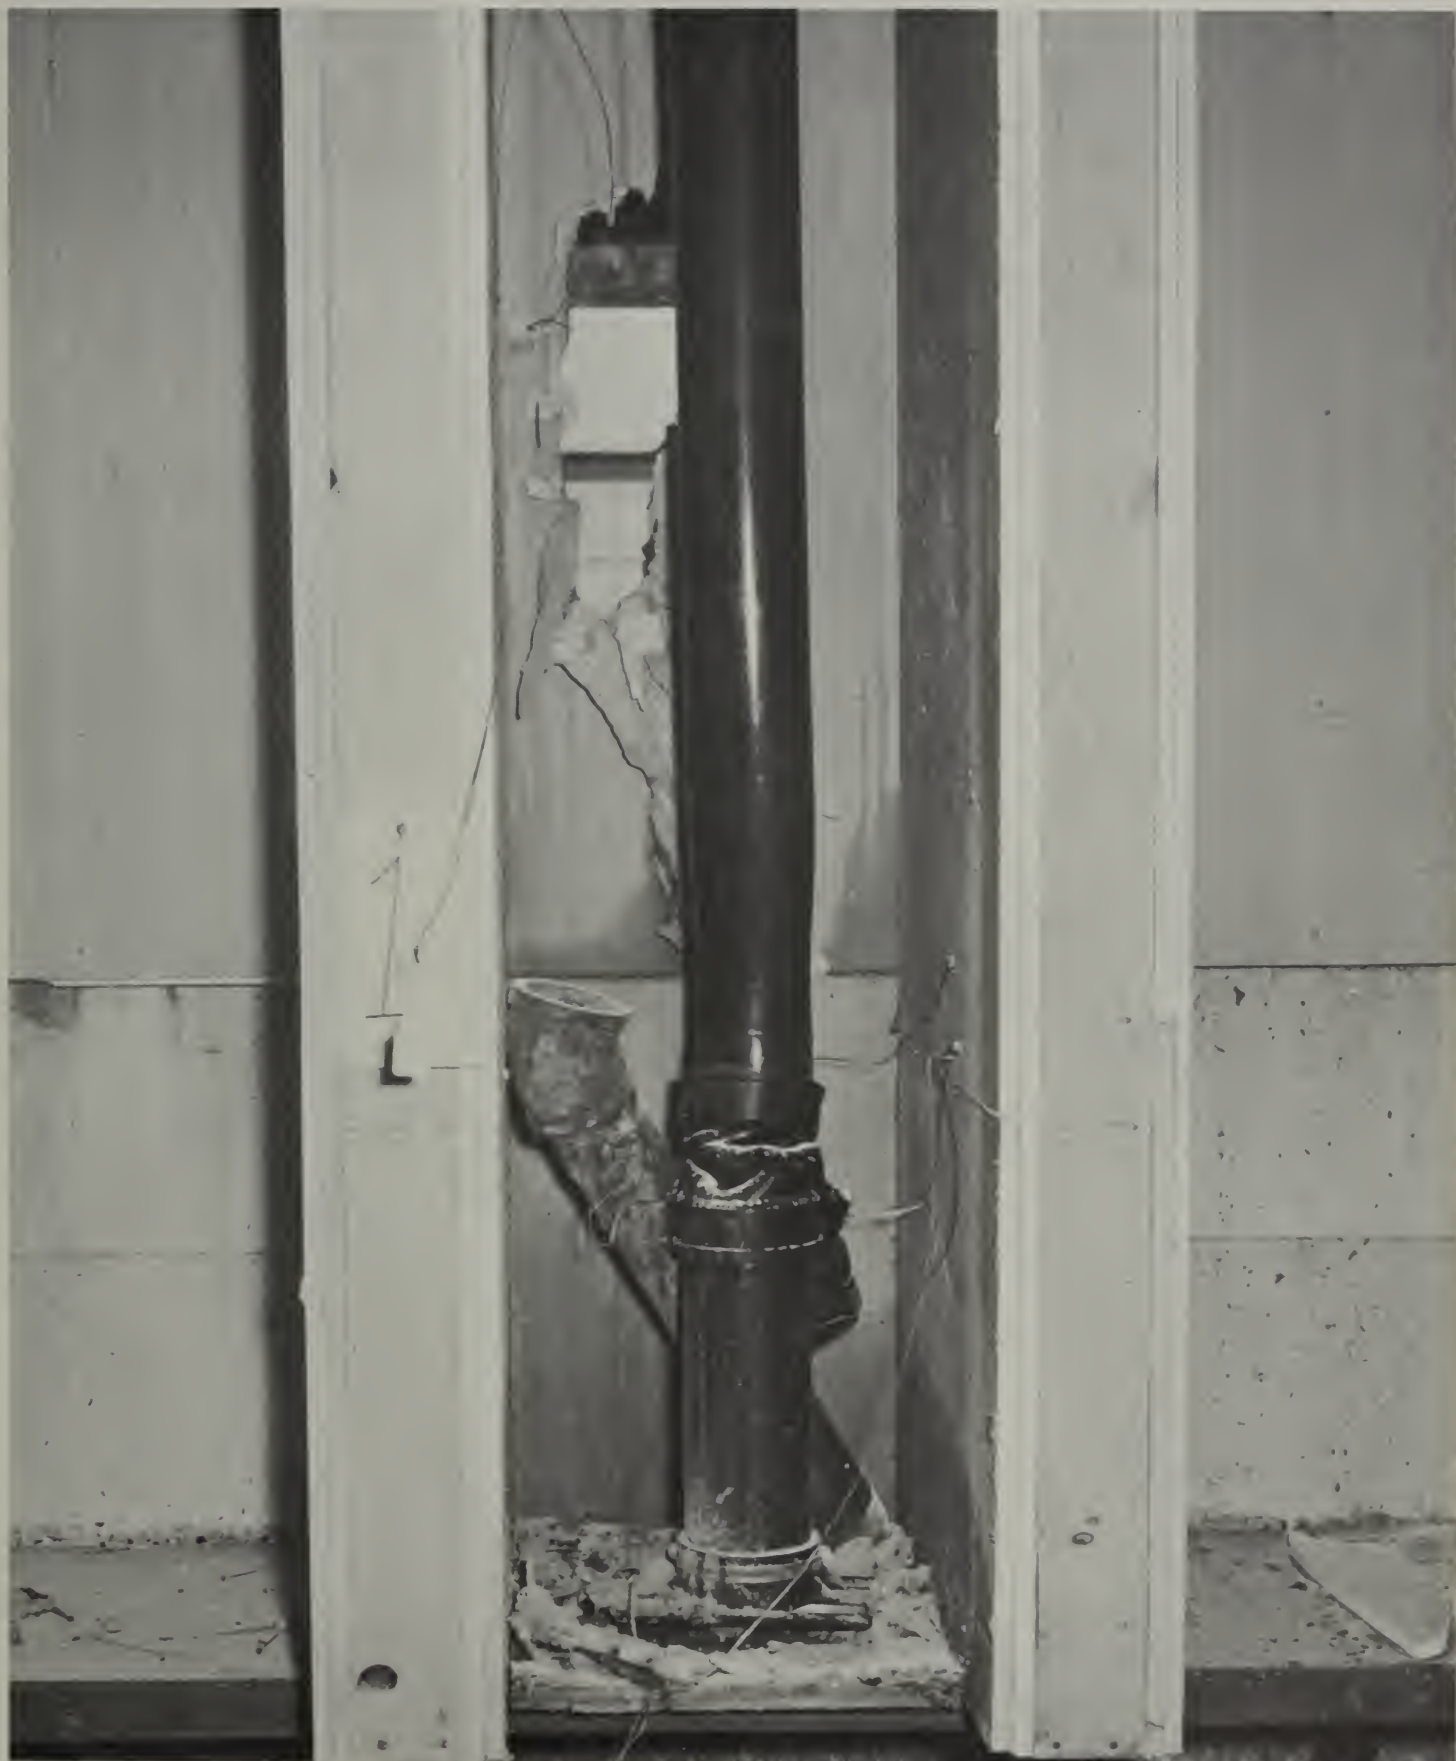
Fig. 12 Lower Part of Chase 1 After Test

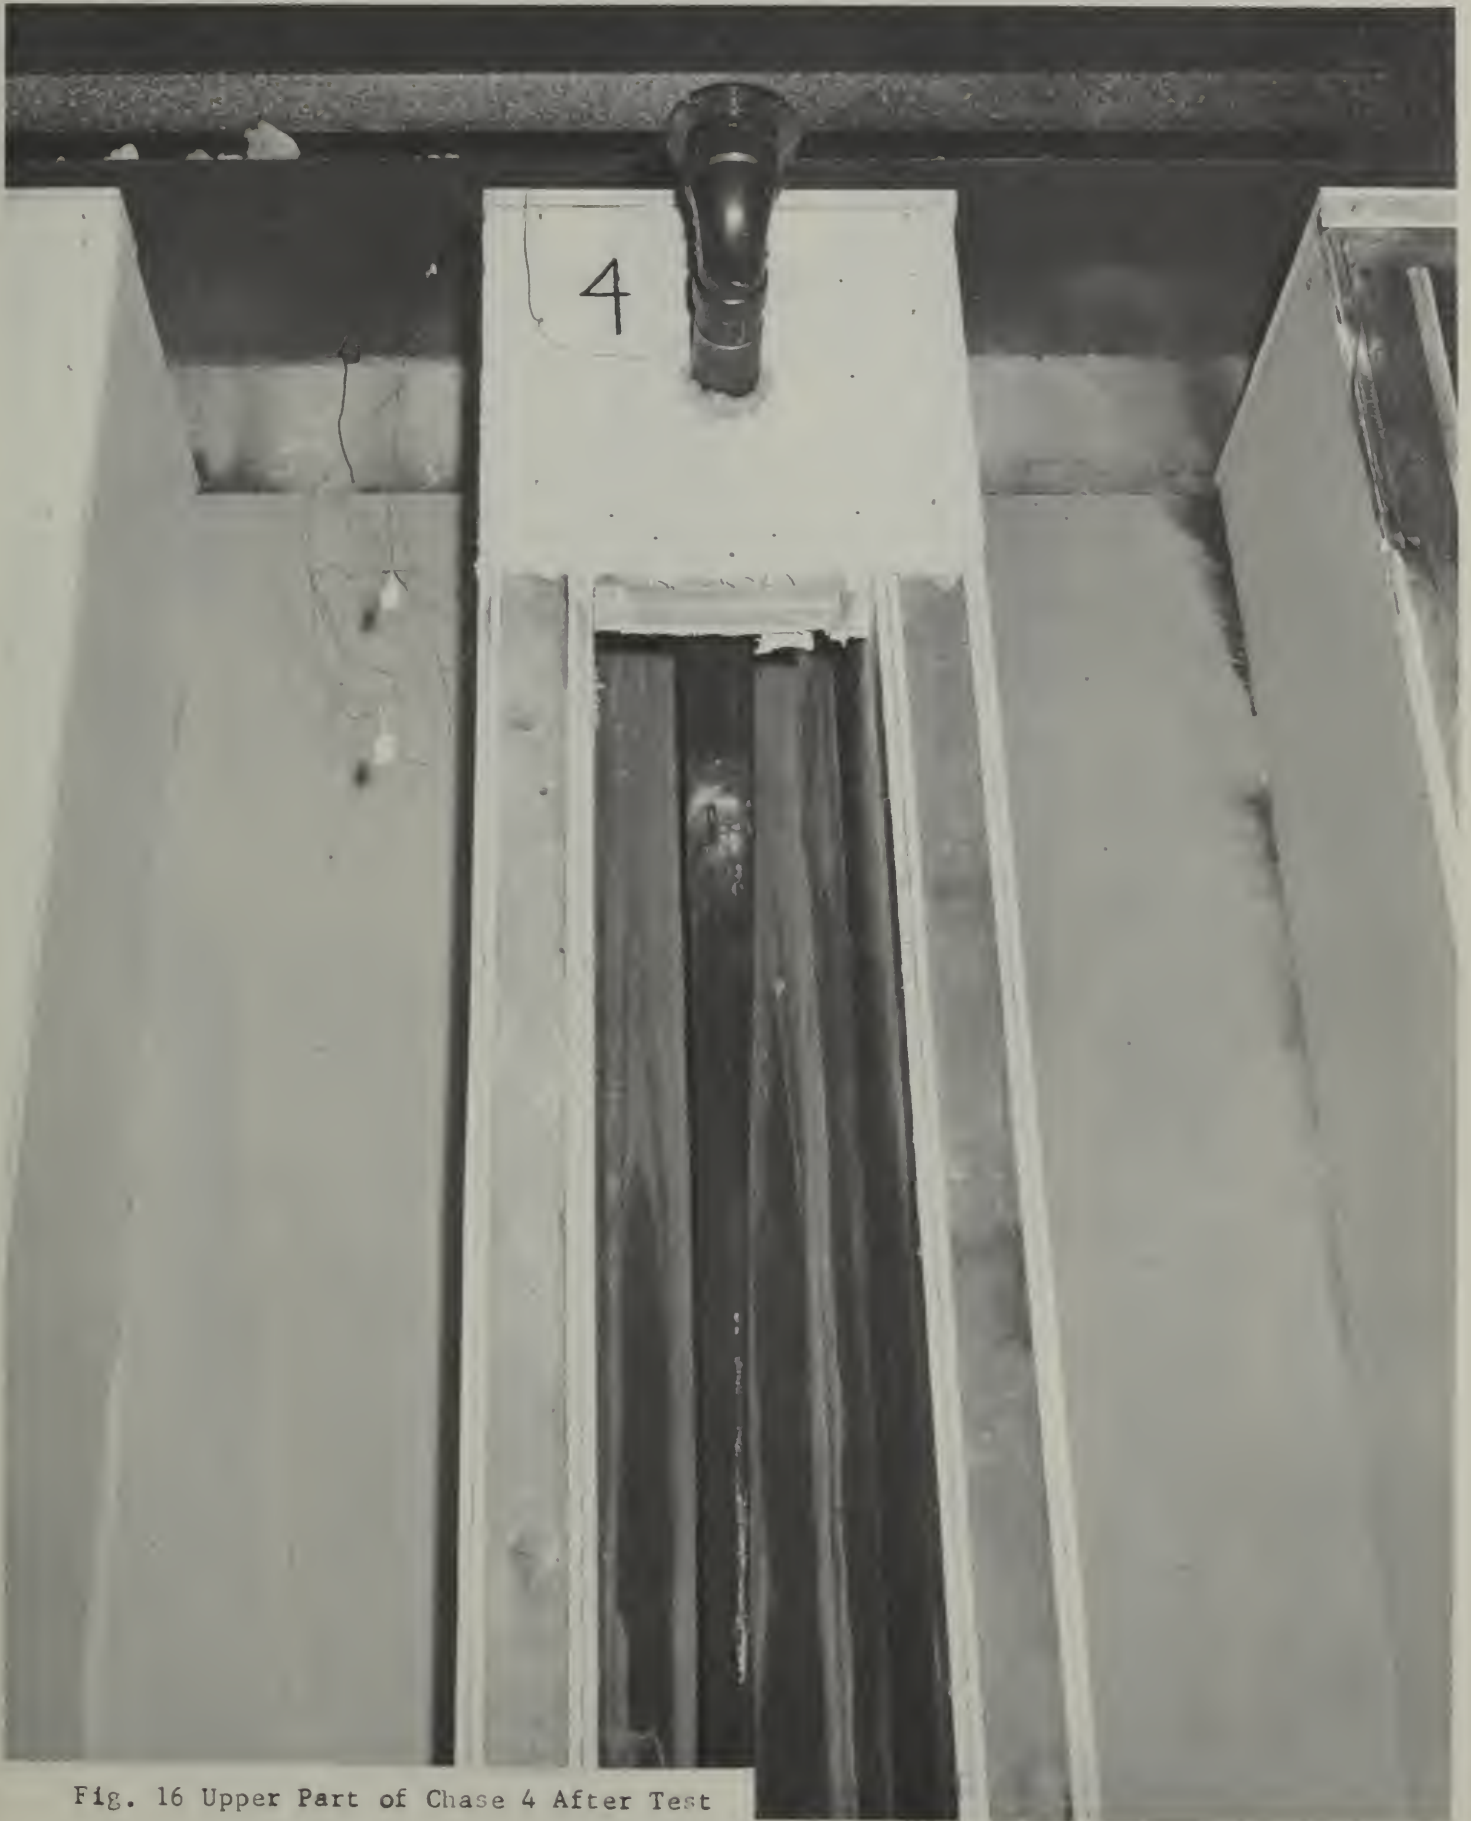
Fig. 16 Upper Part of Chase 4 After Test
